Tamar Estuary  
and Esk Rivers

# TAMAR ESTUARY 2016 REPORT CARD

ECOSYSTEM HEALTH ASSESSMENT PROGRAM  
MONITORING PERIOD DECEMBER 2014 – NOVEMBER 2015

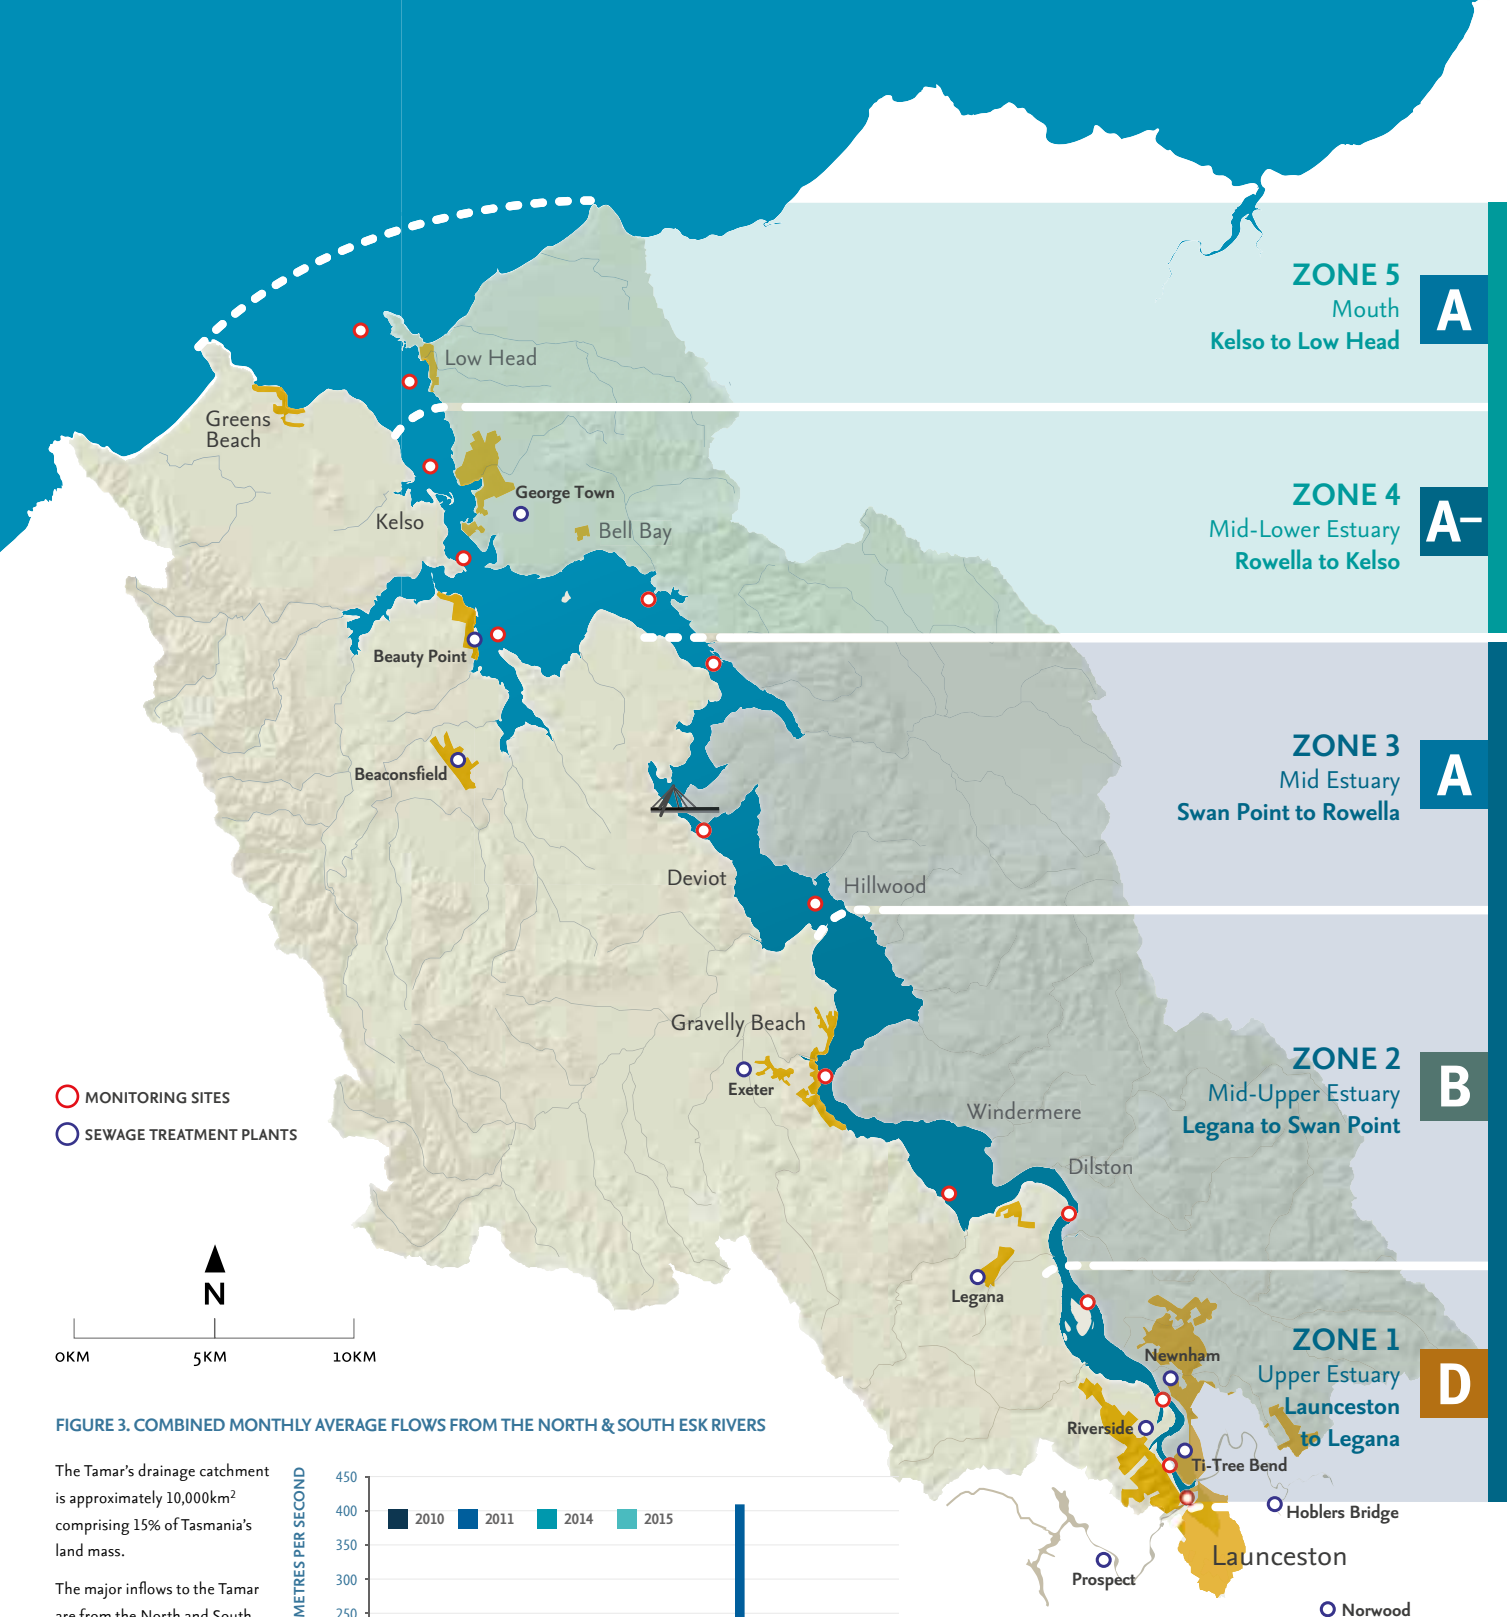
○ MONITORING SITES  
○ SEWAGE TREATMENT PLANTS

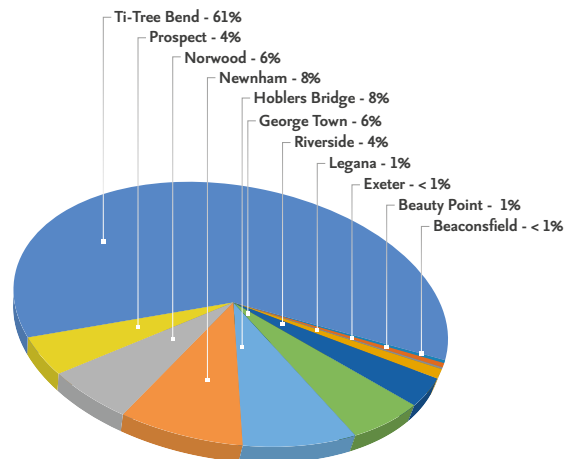
FIGURE 4. PROPORTION OF SEWAGE TREATMENT PLANT DISCHARGE VOLUMES TO THE TAMAR IN 2015 (ML/Yr)

phosphorous and suspended solid loads, operational changes implemented by TasWater in 2015 to address odour management at the Ti Tree Bend STP may have led to a reduction in these pollutant loads. In 2015, the Ti-Tree Bend STP accounted for 61% of the total STP discharge volume to the Tamar (Figure 4).

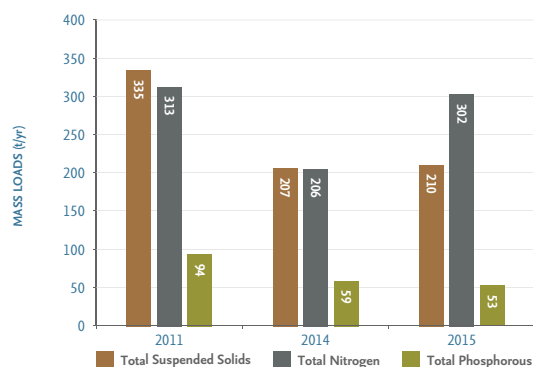
FIGURE 5. ESTIMATED AVERAGE ANNUAL LOADS FROM SEWAGE TREATMENT PLANTS DISCHARGING TO THE TAMAR

Figure 5 shows the nutrient (total nitrogen and total phosphorous) and sediment (total suspended solids) loads discharged to the Tamar River estuary in past reporting years. In 2015, the discharge loads for suspended solids and phosphorous are relatively similar to the loads for 2014. The nitrogen loads however have increased by approximately 30% from 206 t/yr in 2014 to 302 t/yr in 2015. This increase in nitrogen load is likely due to the 18% increase in effluent volume discharged to the Tamar River estuary from STPs compared to 2014. Whilst this increase in discharge would usually result in a similar increase in

TasWater is currently preparing the Launceston Sewerage Improvement Plan (LSIP) which outlines the preferred approach for upgrades to the STPs close to Launceston. The current preferred option for upgrades includes constructing a new northern STP next to the existing Ti-Tree Bend STP. The LSIP proposes to redirect effluent from Legana, Newnham, Riverside, Hoblers Bridge, Norwood and Prospect Vale STPs to the new northern STP. The new northern STP will have significant nutrient removal capability and it is estimated that nutrient load reductions will be approximately 50% for nitrogen and phosphorous and up to 80% for ammonia.

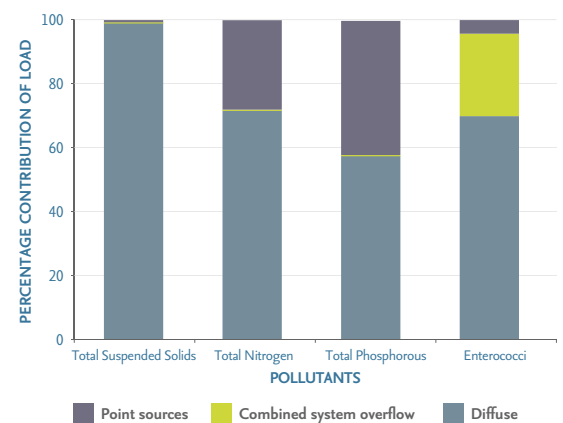
FIGURE 1. ESTIMATED LONG TERM AVERAGE ANNUAL CONTRIBUTIONS OF DIFFUSE AND POINT SOURCE LOADS TO THE TAMAR

Diffuse pollutant loads account for the greatest percentage of loads delivered to the Tamar River estuary contributing approximately 72% of the nitrogen, 57% of the phosphorous, 99% of the suspended solids and 70% of the enterococci (a faecal indicator bacteria).

Point source pollutant loads from STPs and industry account for approximately 28% of the total nitrogen, 42% of the total phosphorous, 1% of the total suspended solids (sediments) and 4% of the enterococci bacteria delivered to the Tamar River estuary.
