Tamar Estuary
and Esk Rivers

TAMAR ESTUARY 2018 REPORT CARD

ECOSYSTEM HEALTH ASSESSMENT PROGRAM
MONITORING PERIOD DECEMBER 2016 – NOVEMBER 2017

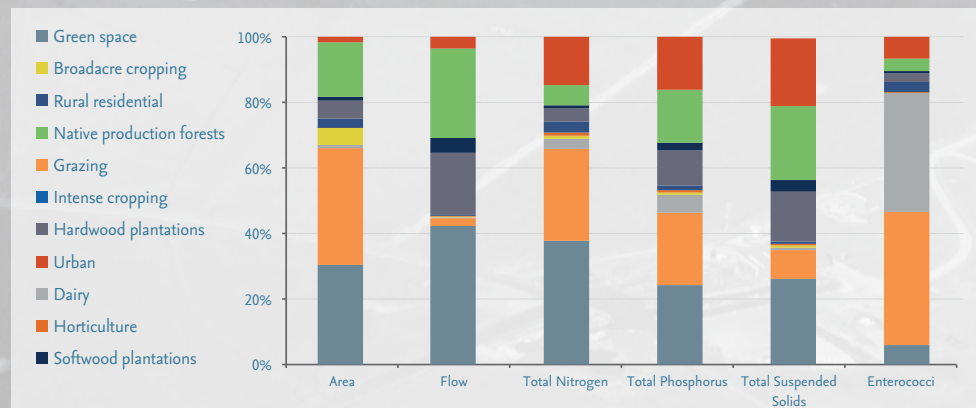
FIGURE 2. ESTIMATED DIFFUSE POLLUTANT LOADS AND FLOW VERSUS LAND USE AREA

Land cover is a significant factor that contributes to the volume of surface runoff, however slope and rainfall are also important contributing factors. For this reason it is important to compare the relative load contribution of land uses not only to their relative area but also to the flows they produce as this is a major driver of pollutant loads, with higher flows contributing higher pollutant loads all other things being equal.

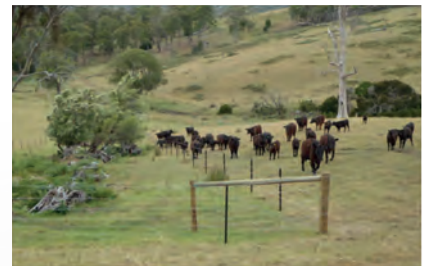
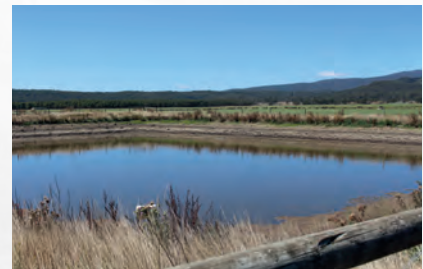
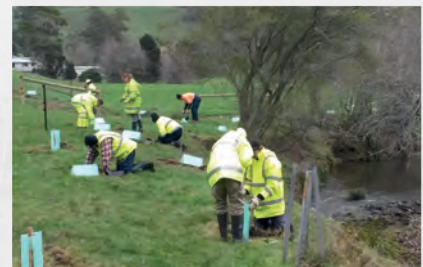
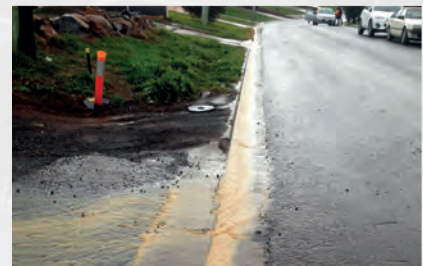
FIGURE 3. SOME OF THE WQIP MANAGEMENT ACTIONS BEING IMPLEMENTED BY NRM NORTH

FENCING STOCK OUT OF STREAMS

IMPROVING DAIRY EFFLUENT MANAGEMENT

RIPARIAN REVEGETATION

SOIL AND EROSION CONTROL WORKS

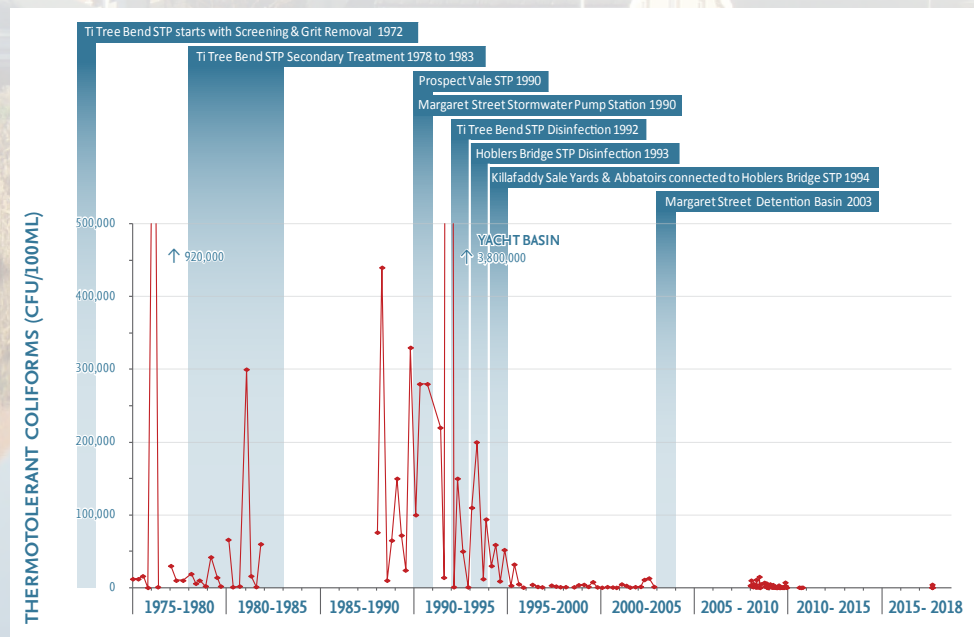
FIGURE 1. HISTORICAL PATHOGEN CONCENTRATIONS IN THE UPPER TAMAR (COLONY FORMING UNITS PER 100ML) (SOURCE: CITY OF LAUNCESTON PROVIDED TO THE TEM FOR THE RIVER HEALTH ACTION PLAN)

From the early 1990s through to 2000s, levels of bacteria were greatly reduced. Improvements in water quality in the upper estuary occurred as a result of improved treatment at STPs, redirection of trade-waste to STPs and upgrades to the combined sewage and stormwater system which reduced overflows from Margaret Street.

Recent levels of bacteria in the Tamar estuary have all been <500 showing a large improvement from years gone by. The last large spikes in bacterial concentrations occurred just before Killafaddy sale yards and abattoir were connected to the Hoblers Bridge STP.
